Batheaston SHLAA site BES 1 – Hawkers Yard

FORM A: BASELINE INFORMATION

Batheaston SHLAA Site BES 2 – Lock-up Garages off Coalpit road

Batheaston SHLAA site BES 5 – Victory Gardens

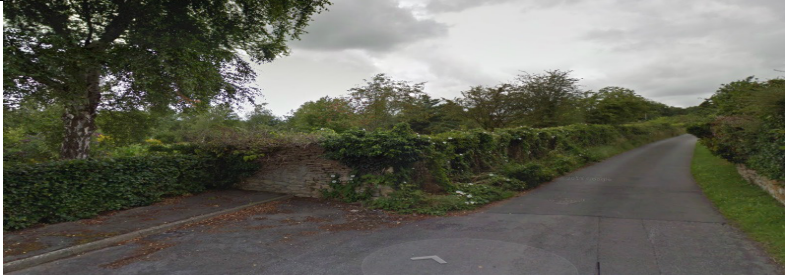
General quality of access	Tick one
Good: Easy access into the site and good roads approaching it.	X
Number of Accesses. Type (vehicle or pedestrian) Observations / Comments / Site Visit Notes / Record of Photos Key Issues and Possible Mitigation (if Fair or Poor) One main access road for vehicles and pedestrians. Approach road is fairly narrow although not heavily used by traffic (See photo)

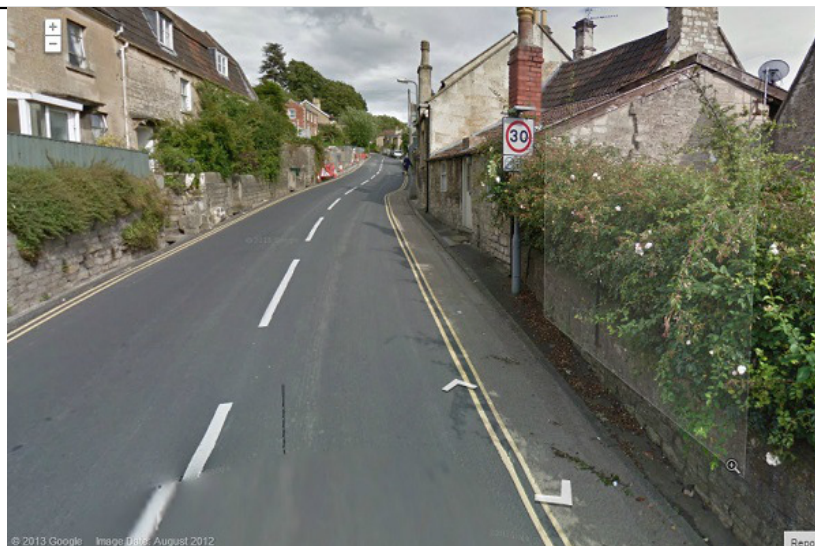
The lower end of Bannerdown Road is dangerous due to a very narrow section of the Road which does not have any pavements.
